EFFECT OF STIRRUP CORROSION ON THE SHEAR STRENGTH OF REINFORCED CONCRETE SHORT BEAMS

Ahmed K. EL-SAYED, Raja R. HUSSAIN, Ahmed B. SHURAIM

Center of Excellence for Concrete Research and Testing, King Saud University, Riyadh, Kingdom of Saudi Arabia

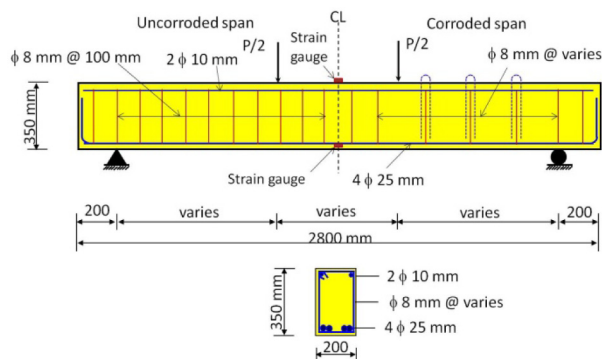
Fig. 1. Typical beam reinforcement and dimensions

The test specimens were 200 mm wide, 350 mm deep, and 2800 mm long. All beams were reinforced with four 25 mm-diameter deformed steel bars as main tensile reinforcement and two 10 mm-diameter deformed steel bars as top reinforcement. The tensile bars were anchored in the test span using a standard hook to prevent anchorage failure. The steel stirrups were deformed bars having a diameter of 8 mm. The side concrete cover of the stirrups was 20 mm. One of the shear spans of the beams was allowed to include corroded stirrups while the other shear span included uncorroded stirrups. The stirrup spacing

in the test span was variable (100, 150, and 200 mm) whereas the spacing of stirrups in the uncorroded span was kept constant at 100 mm for all beams. The test matrix is given in Table 1 and the reinforcement details and dimensions are shown in Figure 1. The beams were divided into two main groups according to the shear span to depth ratio, a/d . The a/d ratios considered were 1 and 2 to reflect the short or deep beam action. According to ACI 318-11 code (ACI 318 2011), deep beams are defined as members loaded on one face and supported on the opposite face, so that compression struts can develop between load points and supports. Moreover, deep beams have either: a) $l_n/h \leq 4$; or b) $a/h \leq 2.0$ where l_n is the clear span of the deep beam, h is the overall depth, and a is the shear span length. Table 1 shows that 8 beams were tested under a/d ratio of 2 and 6 beams were tested under a/d ratio of 1. Each group of beams had beams with corroded stirrups and beams with uncorroded stirrups to serve as controls. The corroded beams included

After completion of the accelerated corrosion process, the beams were tested up to failure. The beams were tested in four-point bending over a simply-supported clear span of 2400 mm, as shown in Figure 1. Each tested beam was loaded directly on the top compressive face with two concentrated loads according to the considered a/d and supported at the bottom. The beams were tested using Amsler Machine with a capacity of 2000 kN. Applied load and reactions were transmitted to the tested beams by means of steel plates to prevent premature crushing or bearing failure at these locations. The dimension of the plates at load point locations were $200 \times 110 \times 25 \text{ mm}$ whereas plates of $200 \times 125 \times 25 \text{ mm}$ were used at the support locations. To ensure uniform contact between

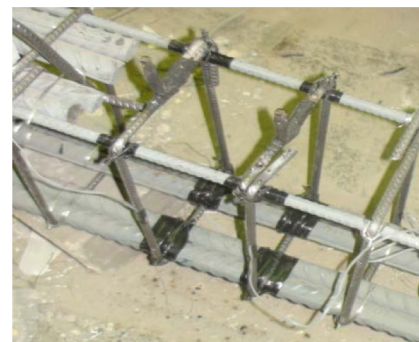
Fig. 2. Stirrup electrical connection

After curing, specimens were subjected to accelerated corrosion. The accelerated corrosion was conducted by impressing a constant current into the concrete beam specimens using an external direct current (DC) power supply. The DC power supply can apply a maximum current of 500 mA with an accuracy of 1%. The steel stirrups were connected to the positive terminal of the power supply to act as an anode. This occurred through a steel bar welded to the stirrup and extended outside the specimen. A 10 mm diameter stainless steel tube bent into a U shape and embedded within the concrete was connected to the negative terminal of the power supply to act as a cathode. The tube was placed around the corroded stirrup, as shown in Figure 1, with an embedment length in

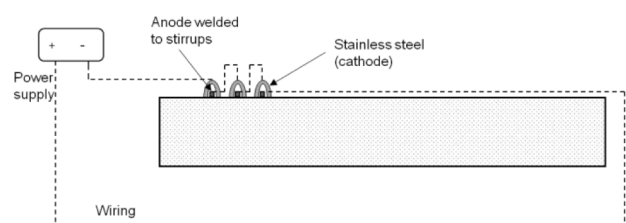
Fig. 3. Schematic of the wiring system

the concrete of 300 mm. The ties used to attach the corrosion stirrups were wrapped in electrical tape to prevent an electrical connection with the longitudinal reinforcement. Also, the longitudinal reinforcement was covered with electrical tape at the stirrups location. The longitudinal steel bars were epoxy coated to preclude corrosion of these elements. Figure 2 illustrates the electrical connection of the corroded stirrups. For the purpose of an accelerated corrosion, a current density of 0.4 mA/cm^2 was applied through the stirrups using the DC power supply. Faraday's Law was taken as guidance for determining the amount of time to produce the corrosion damage. A compressed air mist nozzle was used to spray mist over the test specimens to facilitate the corrosion reaction. Figure 3 shows the wiring schematic and Figure 4 illustrates the corrosion setup.

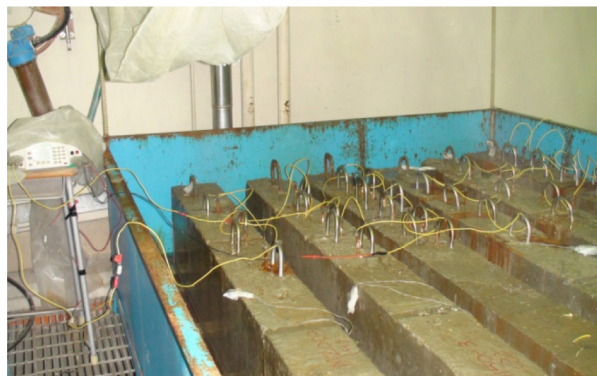
Fig. 4. Accelerated corrosion setup

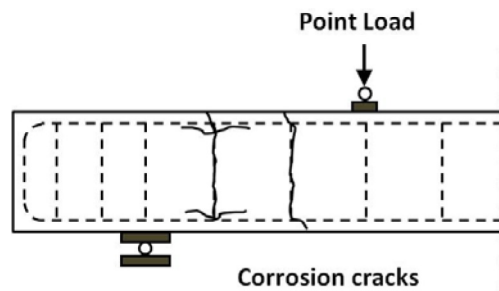
Fig. 5. Typical corrosion crack pattern

During the accelerated corrosion process, all corroded beams showed corrosion cracks and rust staining. The cracks produced from corrosion were traced and recorded. The cracks were primarily vertical at the locations of the vertical stirrups. Secondary longitudinal cracks propagated at or near the location of the longitudinal steel, even though the longitudinal steel was not corroding. A typical corrosion crack pattern is schematically shown in Figure 5.

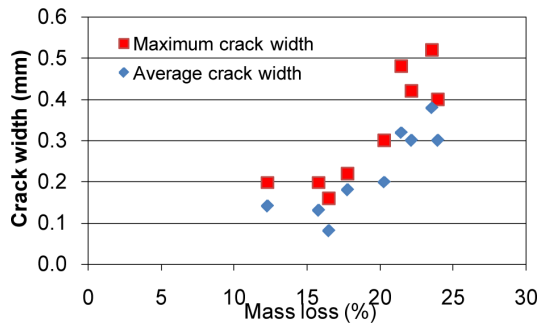
Fig. 6. Correlation between corrosion crack width and mass loss

The correlation between maximum or average crack width and the actual mass loss of the corroded stirrups is presented in Figure 6. As a general trend, both maximum and average crack width was increased as the actual mass loss increased. This correlation between width of corrosion

crack and section mass loss of stirrups reflects the possibility of the corrosion cracks to serve as a measure of the damage extent caused by corrosion. For corrosion-damaged members in real structures, the average mass loss is very difficult to be evaluated while the corrosion crack width can be practically measured.

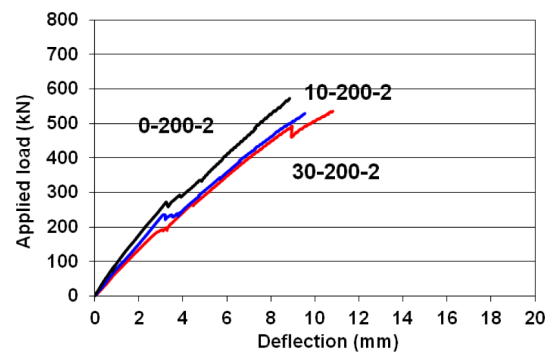
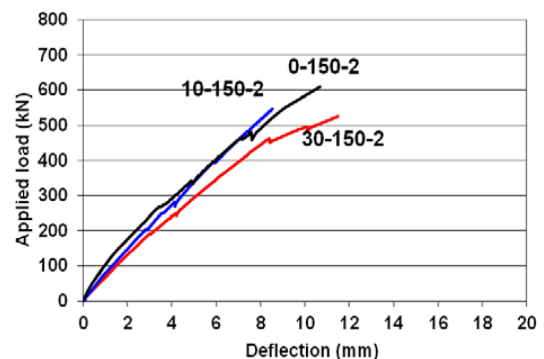
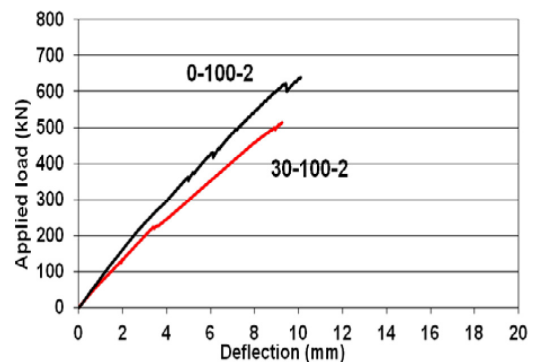
(a) Beams of 200 mm stirrup spacing

(b) Beams of 150 mm stirrup spacing

(c) Beams of 100 mm stirrup spacing

Fig. 7. Load-deflection relationship for beams of a/d = 2

The applied load versus midspan deflection plots for beams of a/d ratio of 2 are shown in Figure 7 whereas Figure 8 shows the deflection plots for beams of a/d ratio of 1. Each figure presents the load-deflection response for beams having the same stirrup spacing. The figures indicate that the corroded beams experienced higher deflection than the corresponding control beam at the same load level. The stiffness degradation in the corroded specimens can be attributed to the corrosion cracking and loss of bond between the corroded stirrups and concrete. This result indicates that corrosion of shear reinforcement affects the flexural behaviour of beams by producing higher deflection that may lead to serviceability problems.

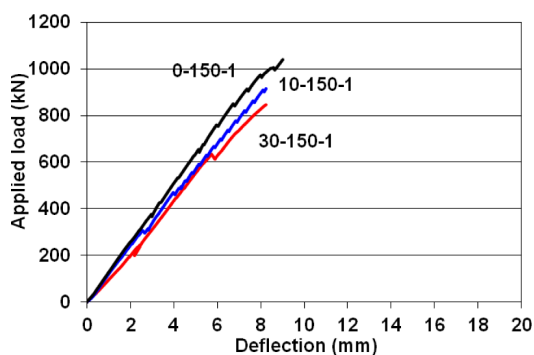
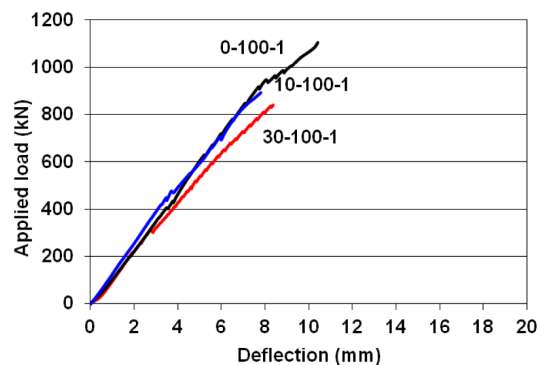
(a) Beams of 150 mm stirrup spacing

(b) Beams of 100 mm stirrup spacing

Fig. 8. Load-deflection relationship for beams of $a/d = 1$

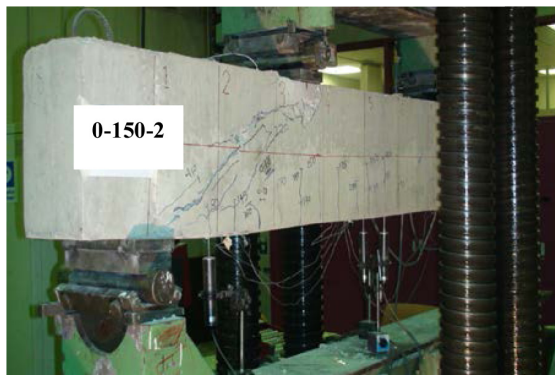
(a) Shear compression failure (0-150-2)

Fig. 9. Failure modes

points was observed. Three failure modes were obtained: shear-compression failure, rupture of stirrups, and diagonal crushing failure. The shear-compression failure is characterized by crushing of the concrete above the upper end of the inclined crack. Most of the control beams with uncorroded stirrups in addition to beam 30-100-2 with corroded stirrups failed in shear compression. All corroded beams with a/d of 1 and 2 failed by rupture of stirrups except beams of closely spaced stirrups (100 mm spacing). Rupture of stirrups occurred due to the reduction in cross-sectional area of the bars caused by

corrosion. The three beams with a/d of 1 and stirrup spacing of 100 mm failed in crushing of the diagonal strut, as given in Table 3. Figure 9 illustrates by photographs the three modes of failure observed in this investigation.

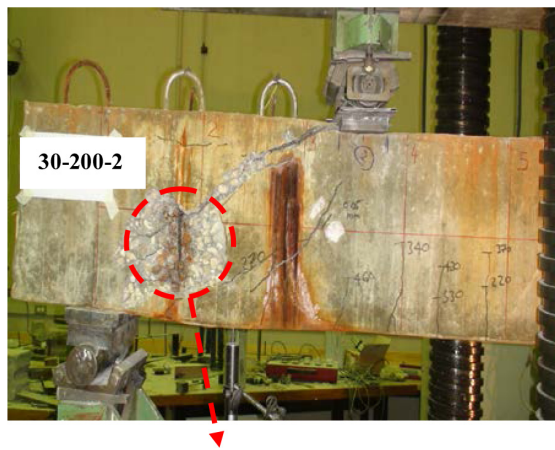
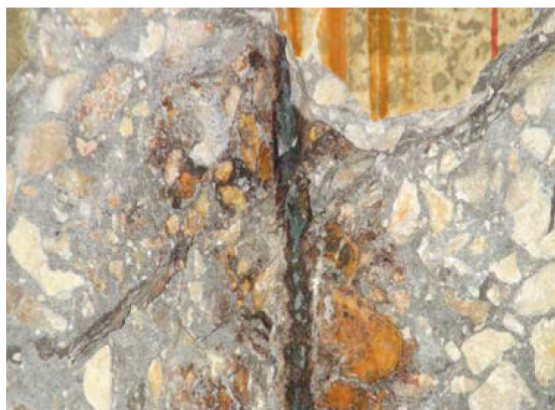
(b) Stirrup rupture failure (30-200-2)

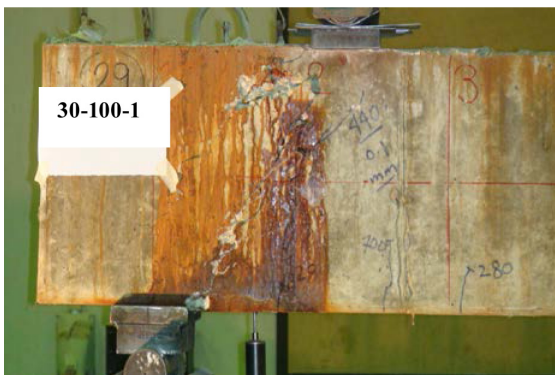
(c) Diagonal crushing failure (30-100-1)

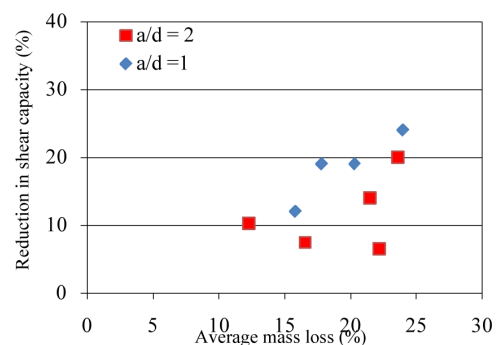
Fig. 10. Variation of reduction in shear capacity with average mass loss

The variation of the reduction in shear capacity was plotted against the degree of corrosion in terms of average mass loss, average corrosion crack width, and maximum corrosion crack width as presented in Figures 10 through 12, respectively. Figure 10 indicates that the shear strength reduction was proportional to the average mass loss of the reinforcing bars; this was more pronounced for the beams of a/d ratio of 1. Figures 11 and 12 clearly indicate that the reduction in shear capacity increased with the increase of both average and maximum corrosion crack width. This observation points out that the corrosion crack width could be employed as an indicator of the residual shear capacity of reinforced concrete beams with corroded stirrups.

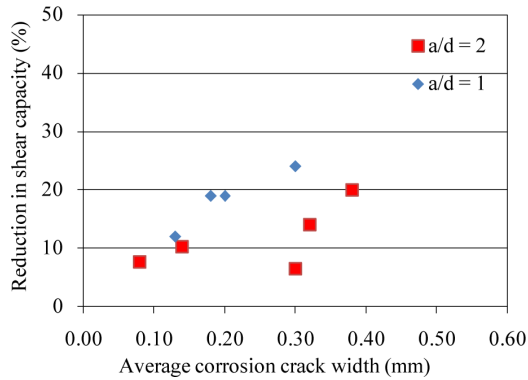
Fig. 11. Variation of reduction in shear capacity with average corrosion crack width

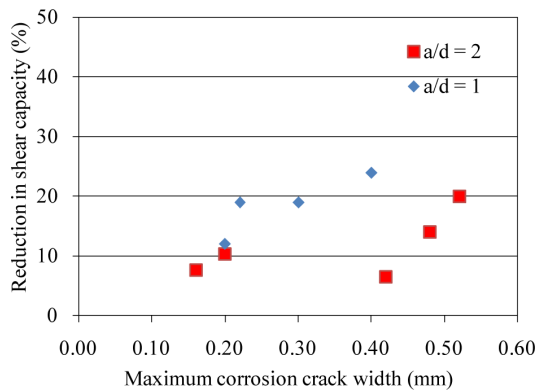
Fig. 12. Variation of reduction in shear capacity with maximum corrosion crack width

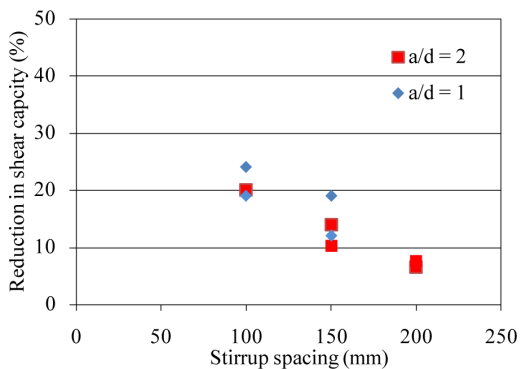
Fig. 13. Variation of reduction in shear capacity with stirrup spacing

The effect of the stirrup spacing on the reduction in shear capacity is presented in Figure 13. The reduction in shear strength became larger for beams with closely spaced stirrups. This result may be expected because more corrosion cracks were developed in such beams in comparison with beams of wider stirrup spacing. The reduction in shear strength was plotted against a/d ratio in Figure 14. The general trend indicates that the reduction in shear capacity increases with the decrease of a/d ratio.

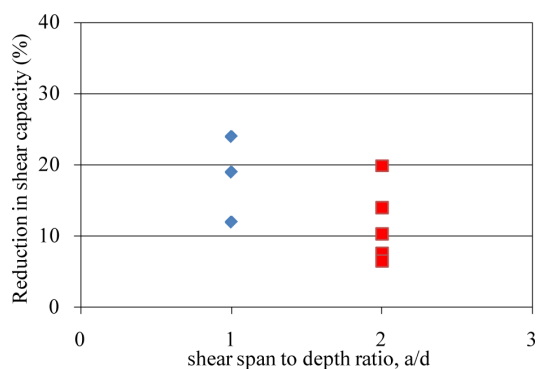
Fig. 14. Variation of reduction in shear capacity with shear span to depth ratio
